Windstorm Mitigation Report

Parkwood Square Apartments, Building A

Windstorm Mitigation Report (OIR-B1-1802)

5890 38Th Ave N, Building A

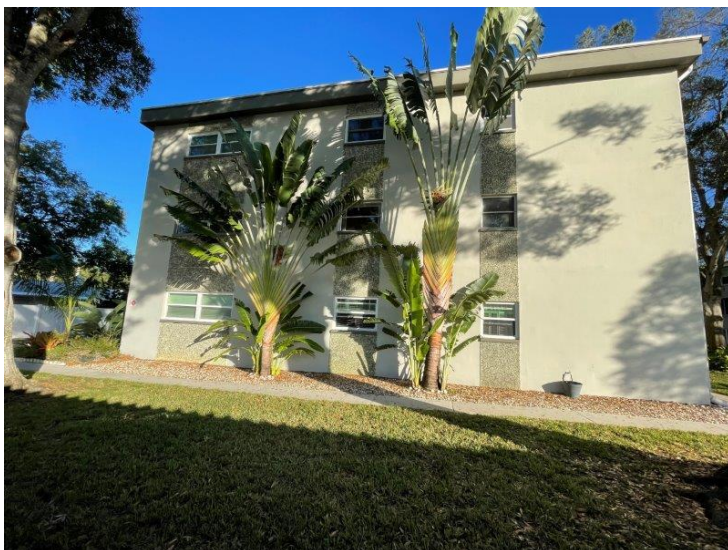
Exterior Elevation

- 5. Roof Geometry:** **Flat Roof**
Comments: Inspection verified a flat roof shape.
- 6. SWR:** **No**
Comments: SWR does not apply to concrete roof decks.

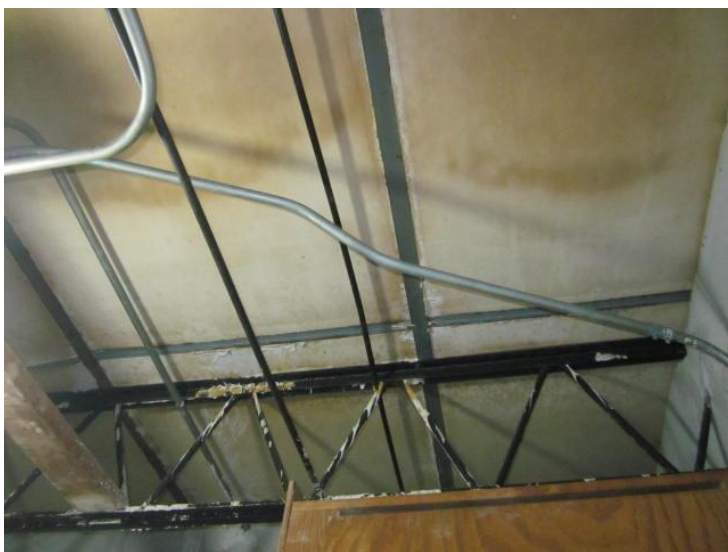
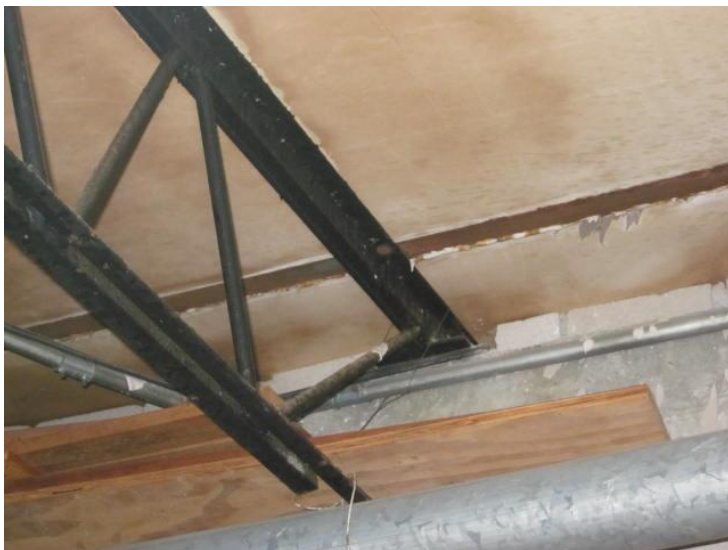
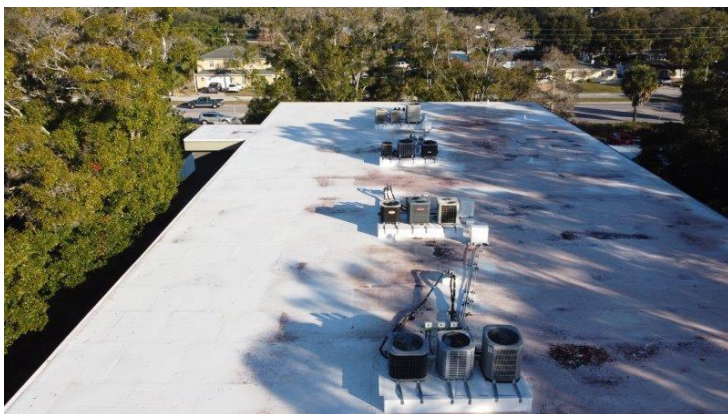
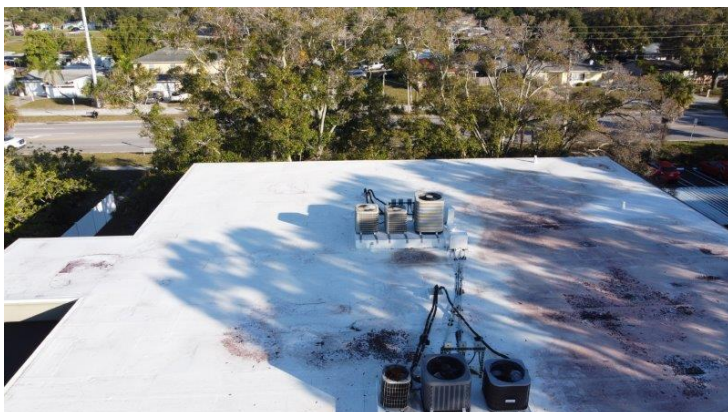
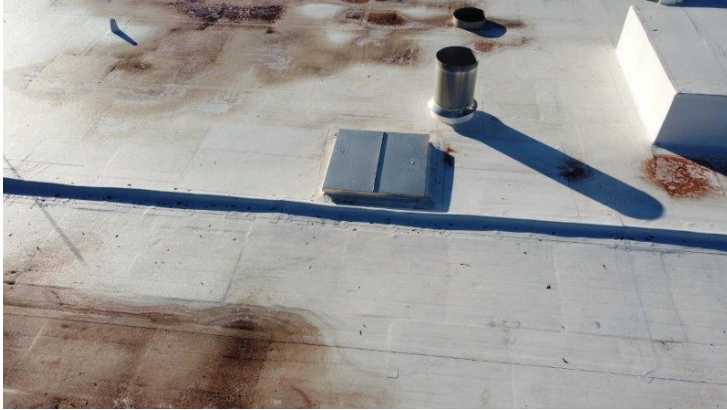
Roof Construction

- 3. Roof Deck Attachment:** **Other**
Comments: Inspection verified a roof deck composed of lightweight concrete gypsum panels supported by steel bar joists.

- 4. Roof to Wall Attachment:** **Structural**
Comments: Inspection verified a roof-wall connection composed of steel bar joists structurally connected to the wall/support system.
